# WET WALLS AND EFFLORESCENCE

*What efflorescence is and how  
to avoid it, with examples  
showing the results of neglect*

Results of two investigations conducted at the  
National Bureau of Standards, U. S. Department  
of Commerce, Washington, D. C., George K.  
Burgess, Director

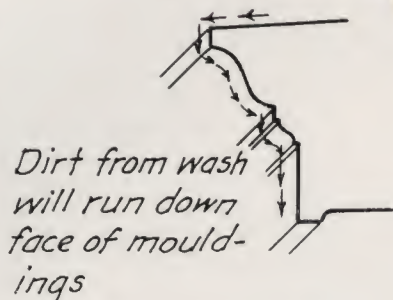
Figure 1. Conventional profile

face of projecting members—this difficulty is overcome, as the water when it reaches this groove drops to the ground." Further than this, only a little consideration is necessary to clearly see that a small drip groove is of little value, as the droplets of water can span such. It is good practice to make the grooves at least  $\frac{5}{8}$ " wide and  $\frac{3}{8}$ " deep. Another necessary precaution is to have the projection at the rear of a coping at least 2" to give room for a drip of this size and to keep the drip away from the wall. **FIGURE 1** illustrates the conventional profile. **FIGURE 2** is no less pleasing to the eye as regards profile and will serve to keep the moldings clean, whereas water and dirt will run down the face of the moldings of **FIGURE 1** and disfigure it as well as the face brick or other materials below it in the wall.

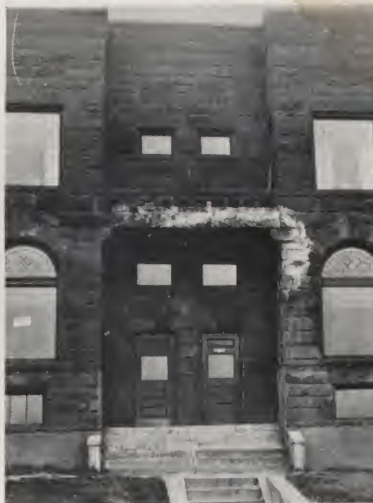
Figure 3. Efflorescence on red sandstone, below porch.

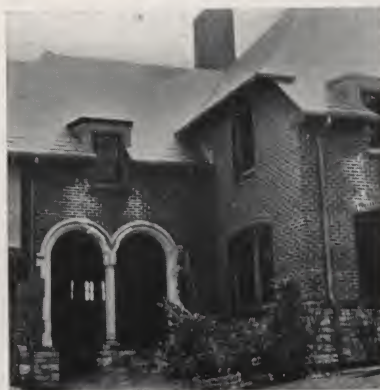
Figure 4. Efflorescence on both brickwork and stone arches.

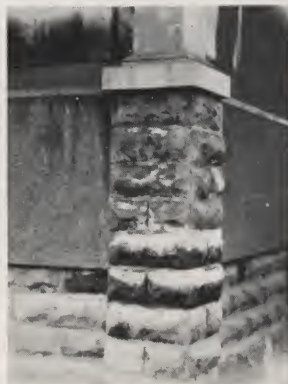
Figure 6. Efflorescence on concrete block.

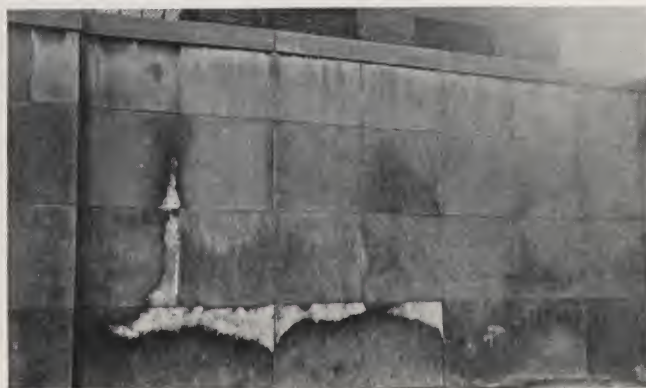
Figure 5. Prompt pointing up of cracks in the mortar joints would have prevented this efflorescence (on sandstone).

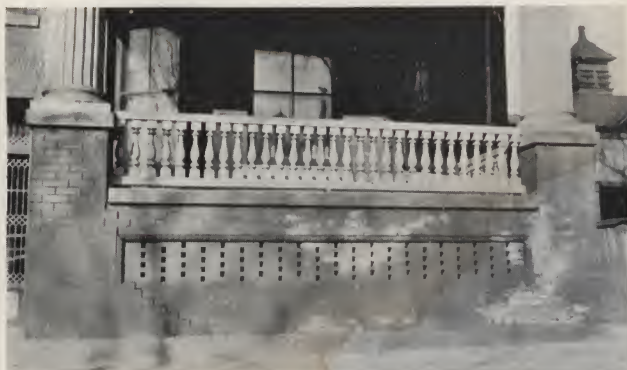
Figure 7. The stone coping has broken loose from the adjoining masonry, allowing water to enter the brickwork.

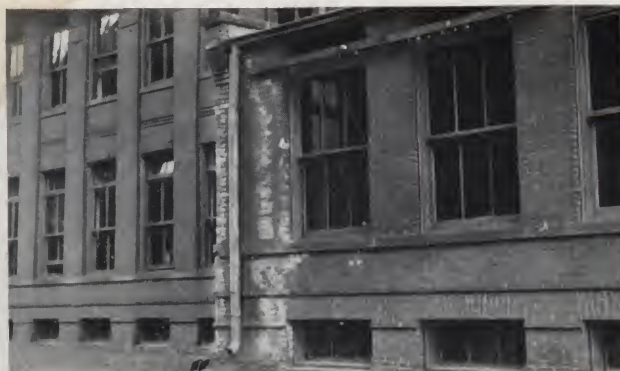
Figure 10. Leaking downspouts are frequent sources of water penetration, leading to efflorescence.

leaders and gutters are very numerous. **FIGURES 9 and 10**, photographs of the same wall, amply illustrate the disintegration induced first by cracks due to settlement and later accelerated by the excessive penetration of water due to a leaking downspout. In this instance, the mortar joints have disintegrated. The courses of brick projecting outward from the wall add to the excessive accumulation of moisture. This point relative to design will be further illustrated in this report. Again, note the efflorescence near the downspout in **FIGURE 11**. This wall is of limestone and its color is nearly the same as that of the salts of efflorescence.

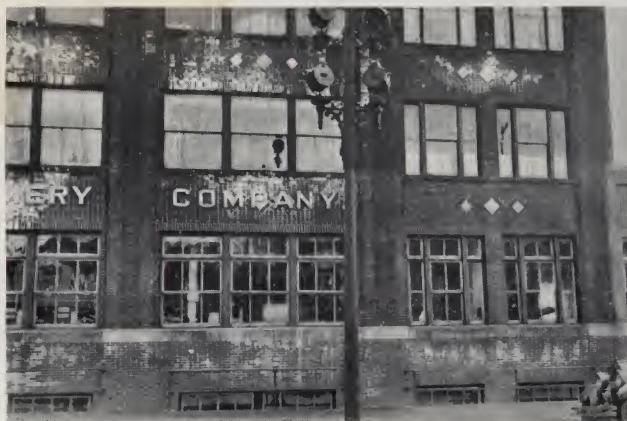
More consideration should be given to the future use of a building by those who design and construct it. **FIGURE 8** shows a creamery covered in places by efflorescence. A photograph of this structure taken two years previous to the time of obtaining the one here given

Figure 8. Water condenses on the inner walls of this creamery except in the office, which is at the right.

also shows efflorescence appearing on the same parts of the wall as those covered with such in this case, two years later. Water condenses inside where operations are carried on. The middle portion of the exterior wall to the right is free from efflorescence. This area is the outer wall of the company's office and consequently there was a dryer interior at this locality. The efflorescence in this instance could possibly have been prevented altogether or at least considerably reduced by waterproofing the entire inner walls of the humid rooms. Waterproofing the exterior surface of these walls would merely result in a progressive accumulation of the efflorescence at those areas where the exterior coating of waterproofing material is defective. Such areas are always developed to a greater or lesser extent.

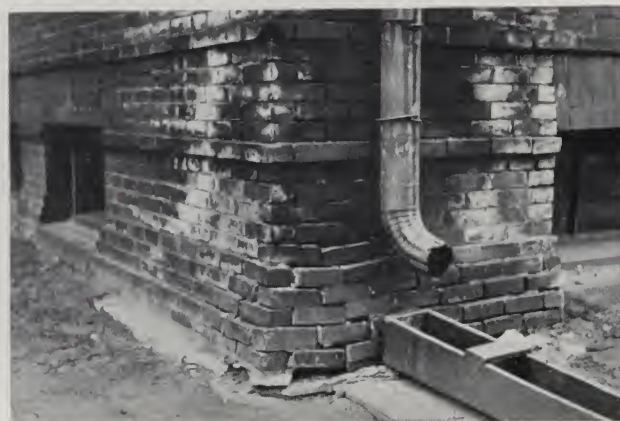
Figure 9. Closer view of wall shown above. Note disintegration of mortar joints.

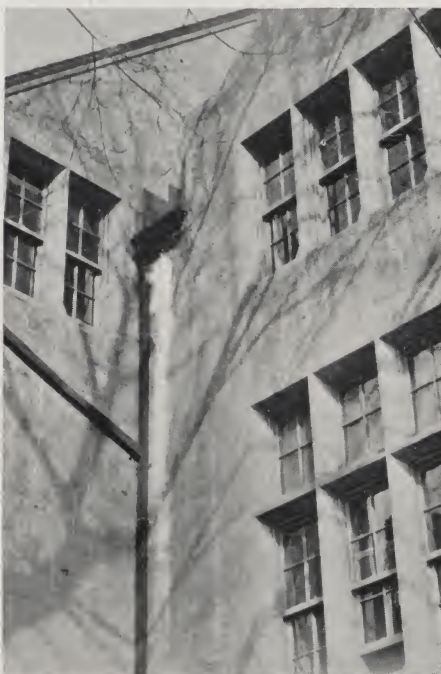
Figure 11. Efflorescence closely follows the downspout on this limestone wall, showing penetration of moisture.

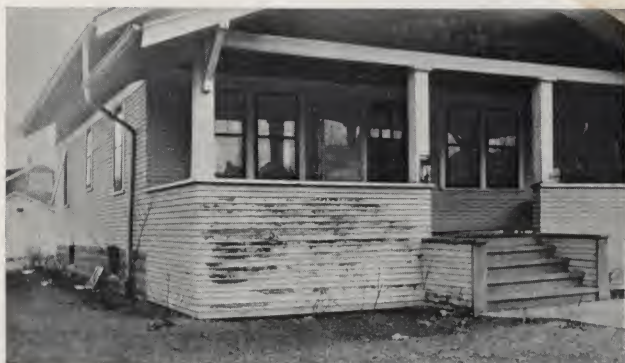
Figure 12. Excessive moisture has here caused the disintegration of paint, as in numberless instances.

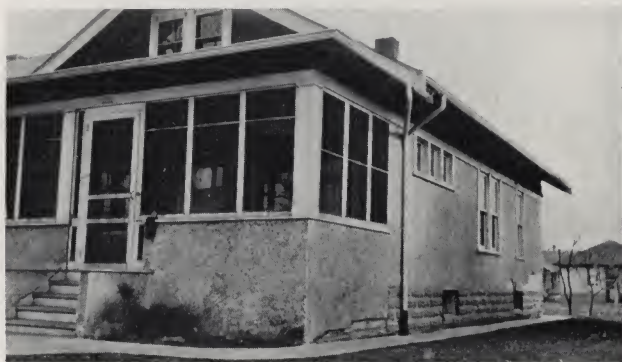
Figure 13a. Seepage and splashing have brought about extensive stucco disintegration at the base of this building.

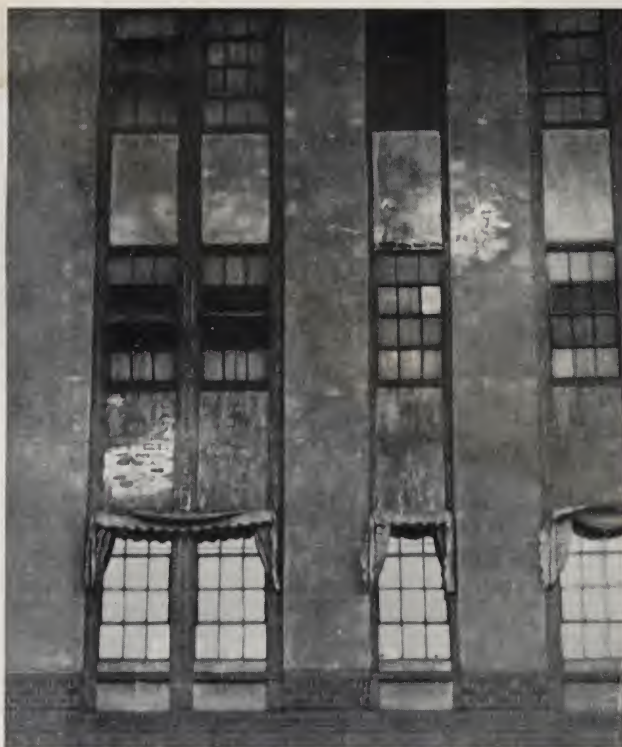
Figure 13b. In addition to causing efflorescence, excessive water penetration has here resulted in disintegration of the stucco, which has fallen off, exposing the brickwork beneath.

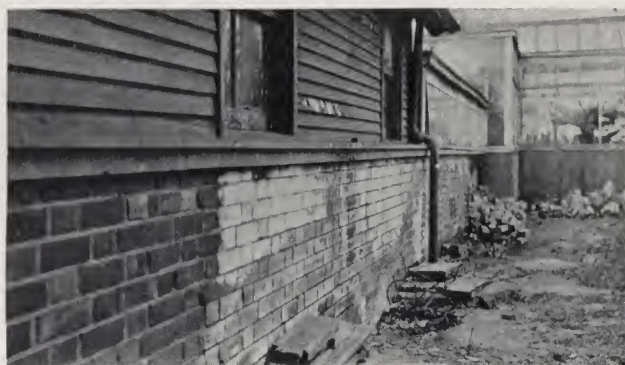
Figure 14a. The unusually severe exposure of this wall has resulted in marked efflorescence.

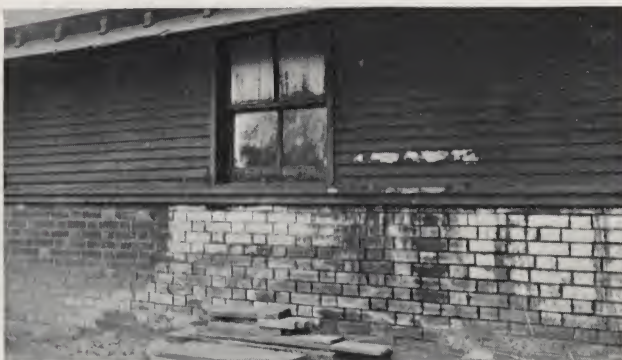
Figure 14b. In this view of the same wall, note the peeling of paint and the failure of mortar joints.

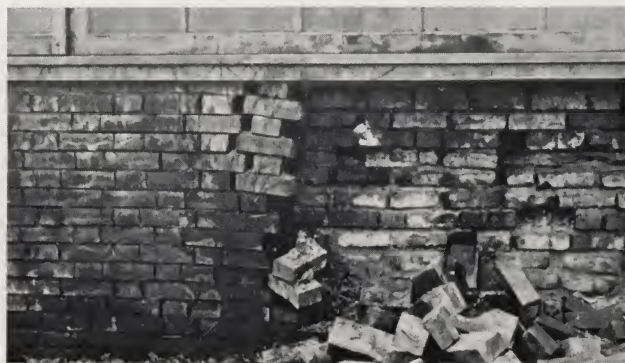
Figure 14c. Here is the final collapse of part of the wall shown in the above illustrations.

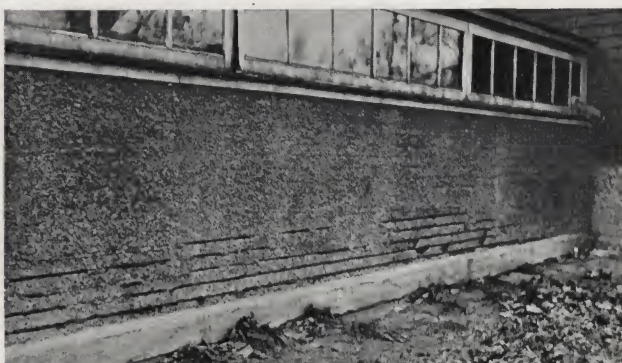
Figure 14d. In this addition to the same wall, both the stucco cover and the mortar joints are disintegrating.

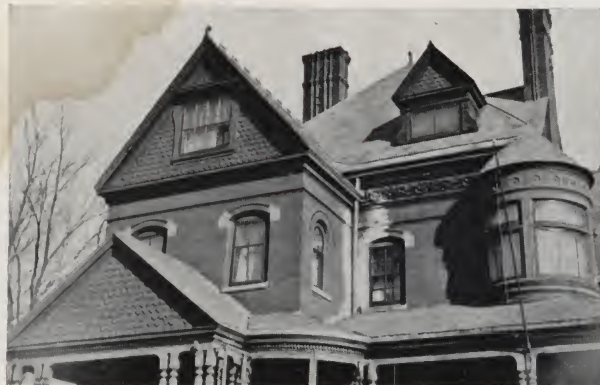
Figure 15. Maintenance alone is at fault in this instance—the gutters are defective.

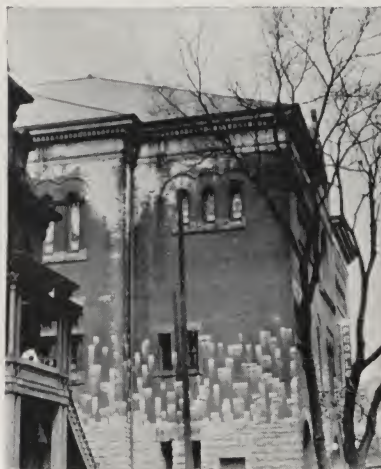
Figure 16. The downspout leaks, and settlement cracks above the stone set in the brickwork have not been pointed up, resulting in much efflorescence.

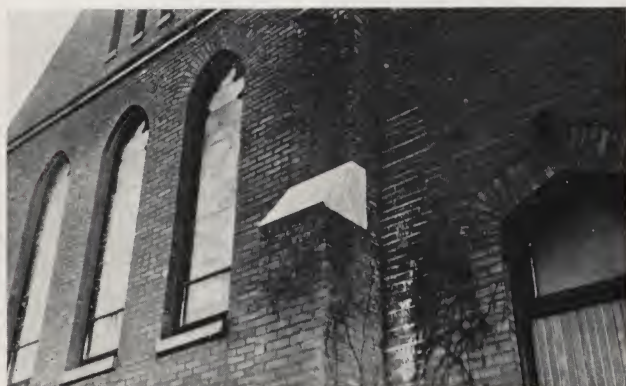
A typical example of wrong design is shown in **FIGURE 17, a and b**. Both are pictures of the same building. There are no drips on the flat inclined stone caps at the top of the buttress piers and the inevitable result is in evidence.

Figure 17a. Efflorescence caused by failure to provide drips on the stone caps over the buttress piers.

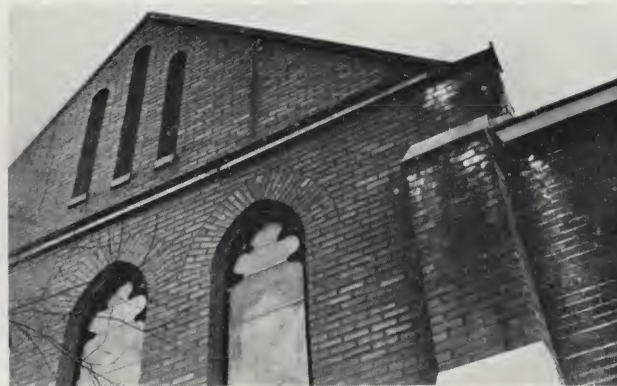
Figure 17b. Another view of the same building illustrating the necessity for adequate drips.

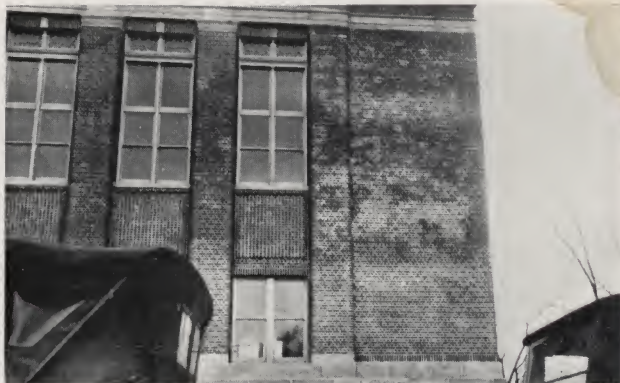
Figure 18. This general efflorescence, chiefly on the mortar joints, probably came from excessive salts in the wall.

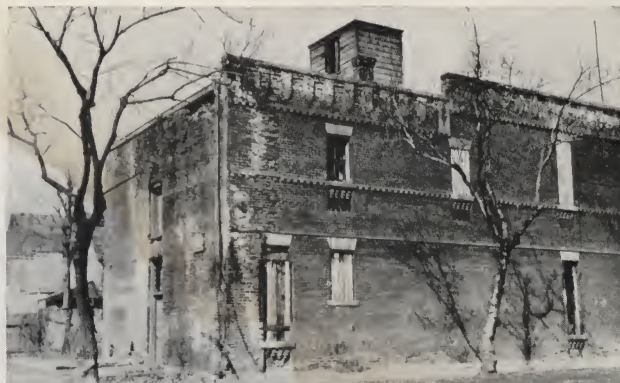
Figure 19. Water has penetrated these walls of underburned brick, because of poor design and poorly constructed coping.

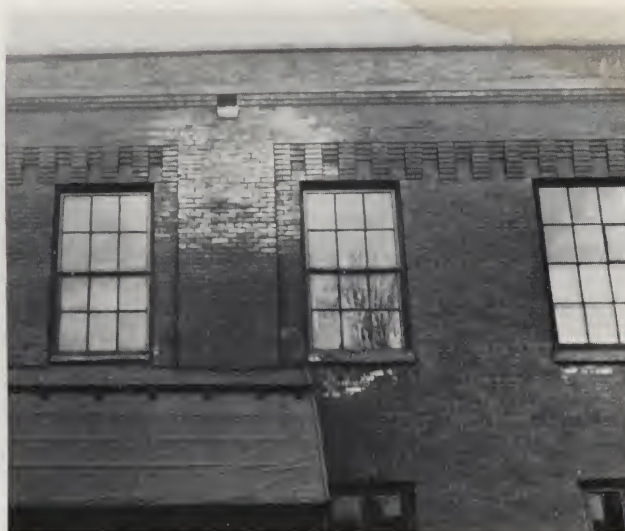
Figure 21. Efflorescence has appeared in this case below the water exit in the parapet wall.

to the wall as to be ineffective), the sills themselves being of soft porous sandstone and not weather resistant and the truncated water exit (FIGURE 21, same building), were the immediate causes in this instance of the efflorescence attended by disintegration.

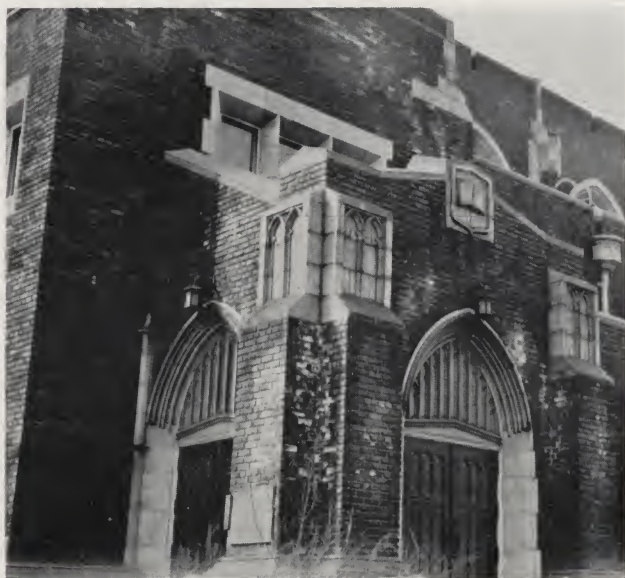
Figure 22a. Defective flashing, absence of suitable drips and projections at the buttress tops caused this trouble.

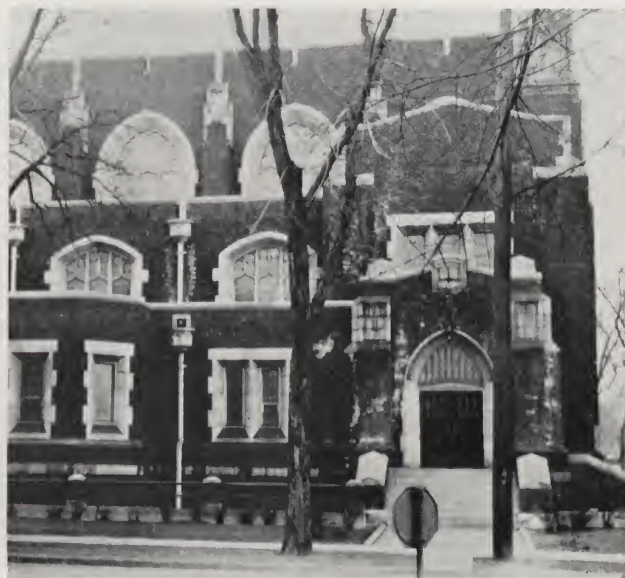
Figure 22b. Faulty maintenance is also responsible in part for the efflorescence shown on this church.

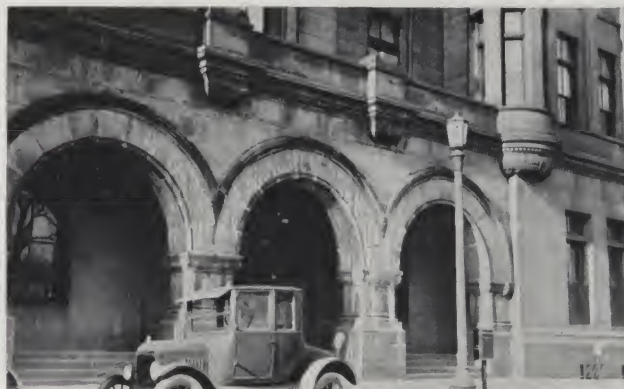
Figure 23. The stonework below the balcony is not protected by flashing and shows marked efflorescence.

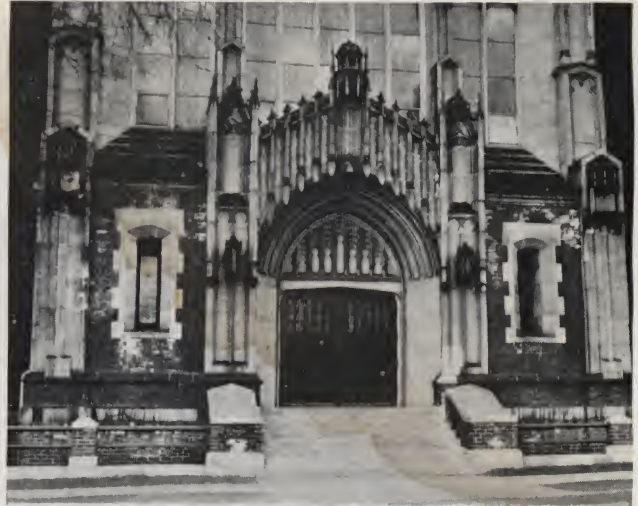
Figure 25. Joints in the window sills have cracked, allowing excessive moisture to enter the brickwork below.

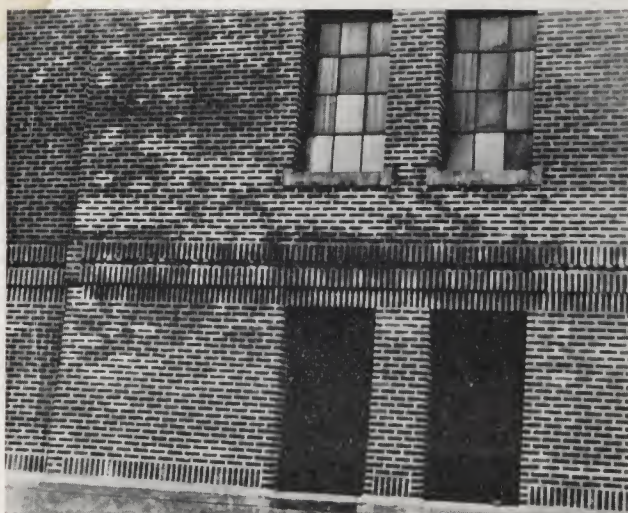
Figure 28. The projecting courses of brick shown here receive excessive moisture.

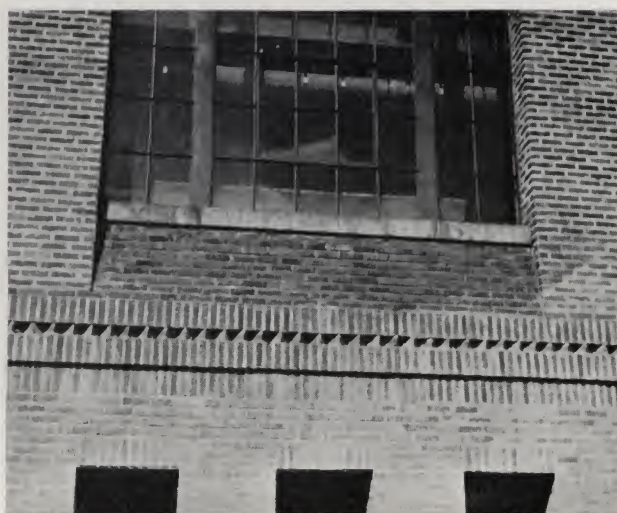
Figure 29. The corbelled area is dark with moisture, and as the building ages, will doubtless show efflorescence and disintegration of joints.

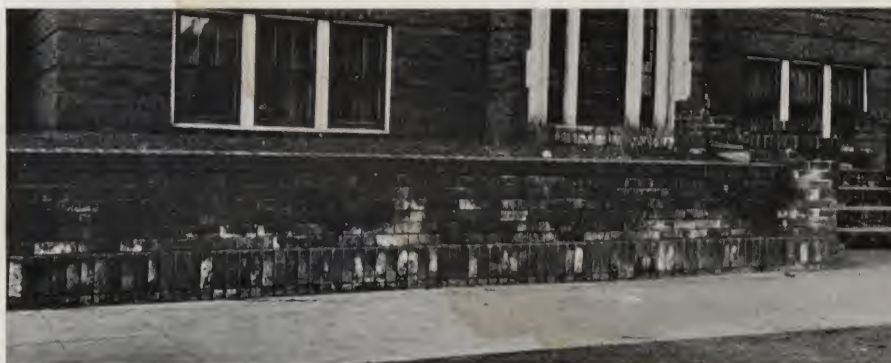
From this illustration to the next, **FIGURE 31a**, there is added the further undesirable condition, soil in immediate contact with the brick in the retaining wall. To have put tar or tar paper back of this wall or still better to have dug a trench back of this wall, lining the trench with impervious concrete and then to have filled the trench with gravel would have been an additional expense well worth while. Within a short time it will be necessary to rebuild this wall and this procedure will cost considerably more than would the initial precautions.

Figure 31a. Moisture has entered this wall from the soil, which is in contact with the brickwork.

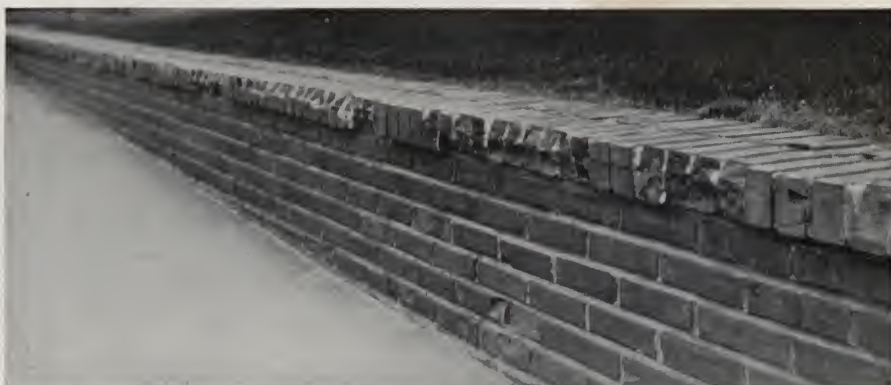
Figure 31b. In retaining walls, the exposure is especially severe. Even well-burned brick, such as were used here, must have adequate drainage to resist frost action.

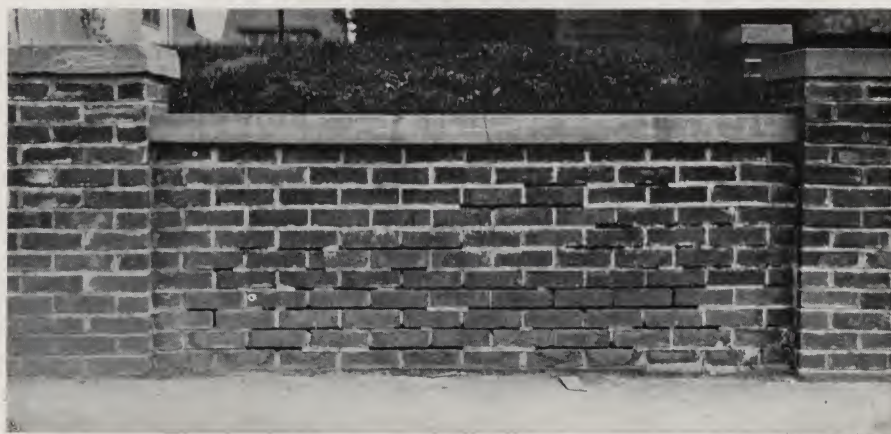
Figure 31c. The mortar joints in this wall have been pointed up twice and need attention again. Direct contact with moist ground at the back of the wall, without insulation or proper drainage, is responsible for this trouble.

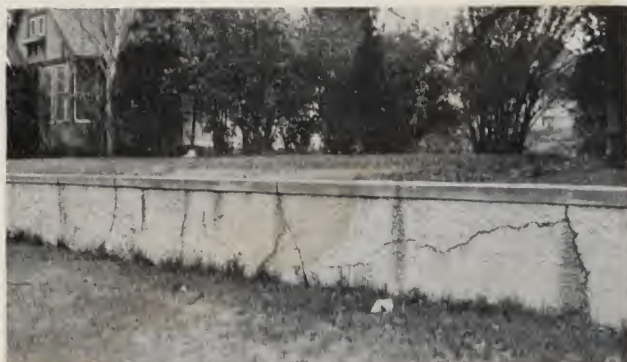
Figure 31d. The vertical joints in the coping have disintegrated, and below each a crack has formed in the concrete.

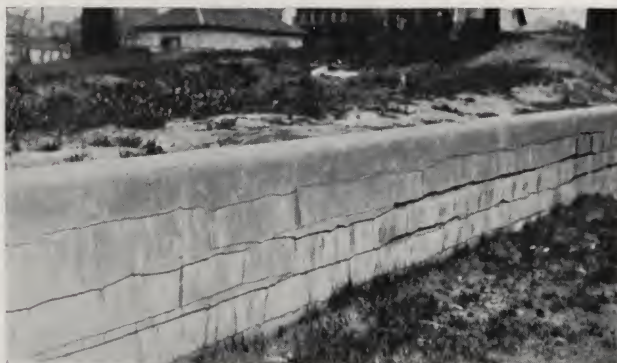
Figure 31e. An endless number of retaining walls in varying stages of failure might be shown.

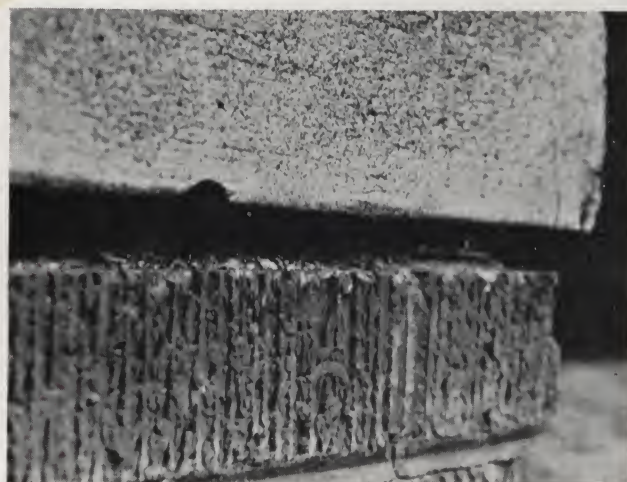
Figure 31f. Under this cap, which has no drip, the mortar has disintegrated badly. This is also part of a retaining wall.

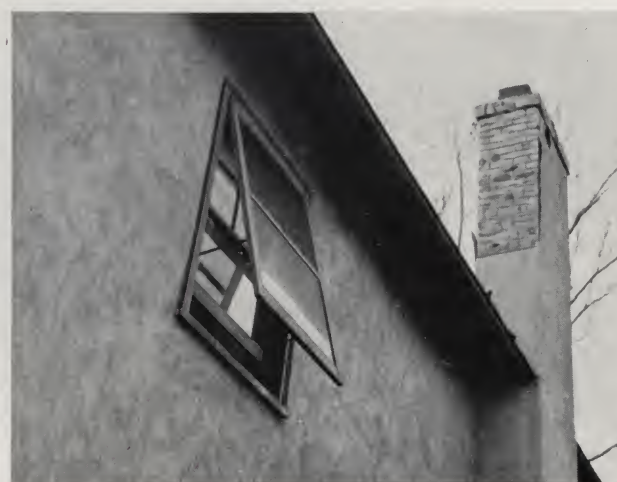
Figure 32. Chimneys receive particularly severe exposure. The vertical mortar joints here have allowed water to enter between the stucco and the brick.

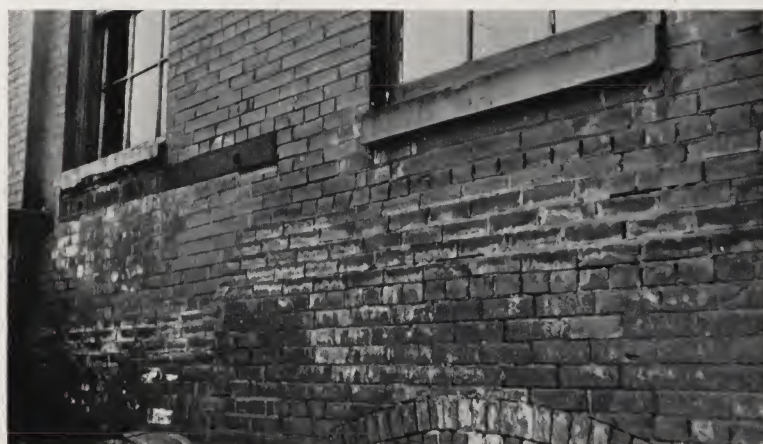
Figure 33. Corbelling of the brick is the chief reason for the failure at the right, whereas the trouble directly under the left window is due in large measure to the sill.

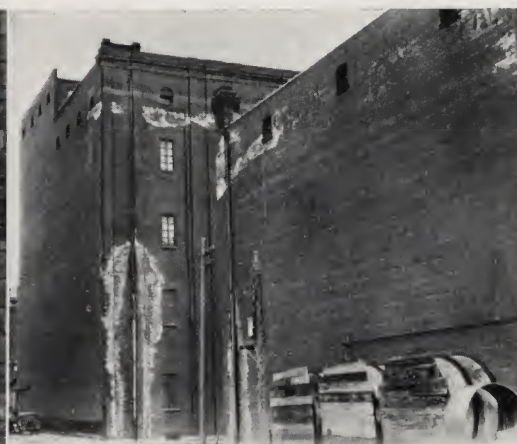
Figure 34. This efflorescence has resulted from a number of clearly recognizable faults of design, construction and maintenance. Figure 33 shows a closeup view of another part of this building.

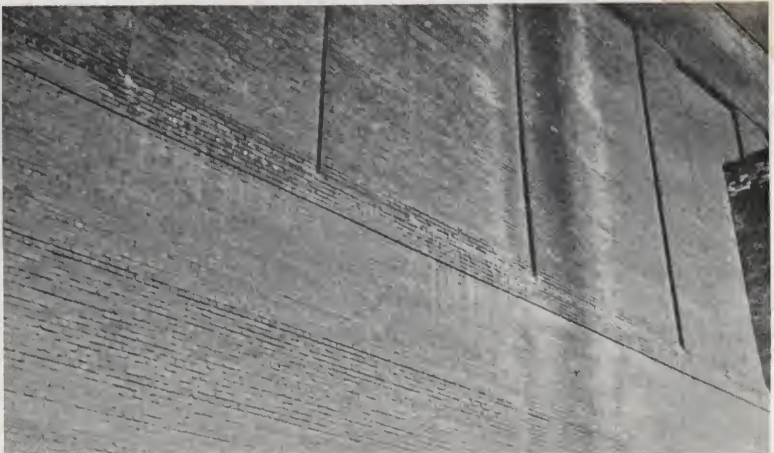
Figure 35b. The walls of this structure are composed of kiln run brick, some of which are underburned.

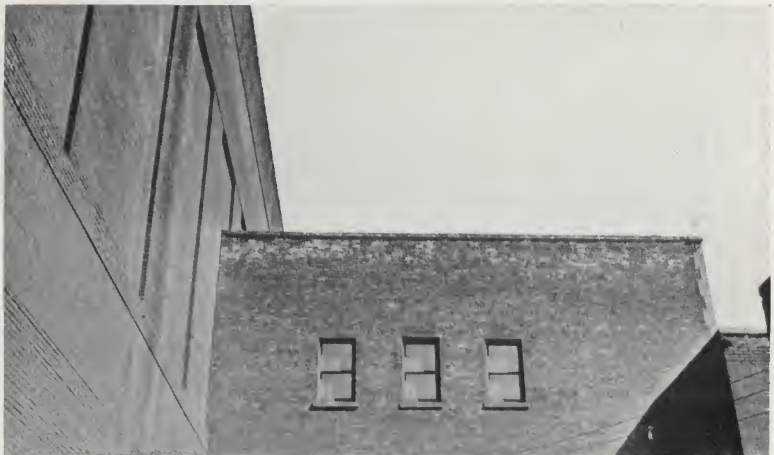
Figure 35c. Disintegration progresses while efflorescence becomes less marked as the soluble salts are washed out.

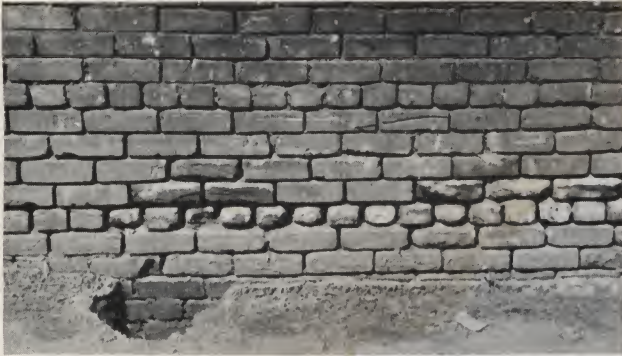
Figure 35d. This closeup reveals the extent to which the mortar joints and even the brick have disintegrated.

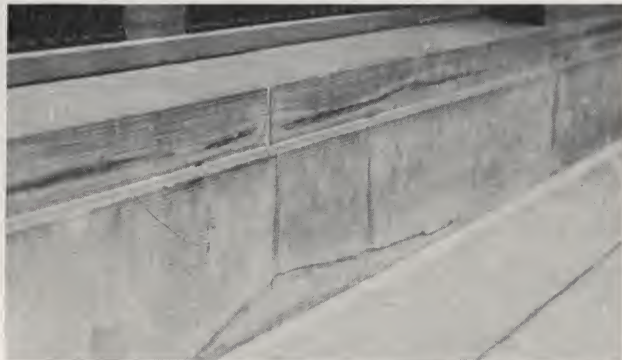
Figure 37. Moisture penetrating this sandstone base has begun its powerful disintegrating action.

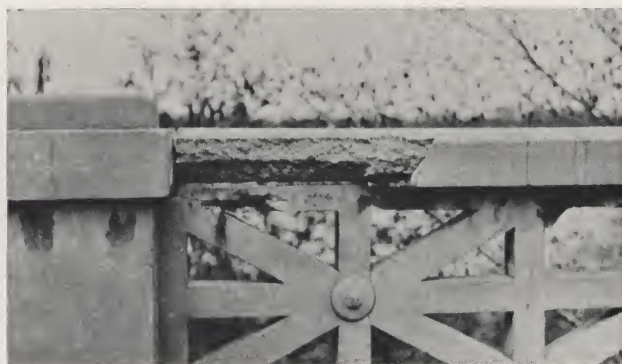
Figure 38. This bridge railing has no drips and too little slope to dispose of the water.
